# Photographic Record Cascade Mine Drainage

DSL-AMRB 91-001

Near Towns of Centerville, Stockett and Belt  
Cascade County, Montana

December, 1992  
Robert Peccia & Associates

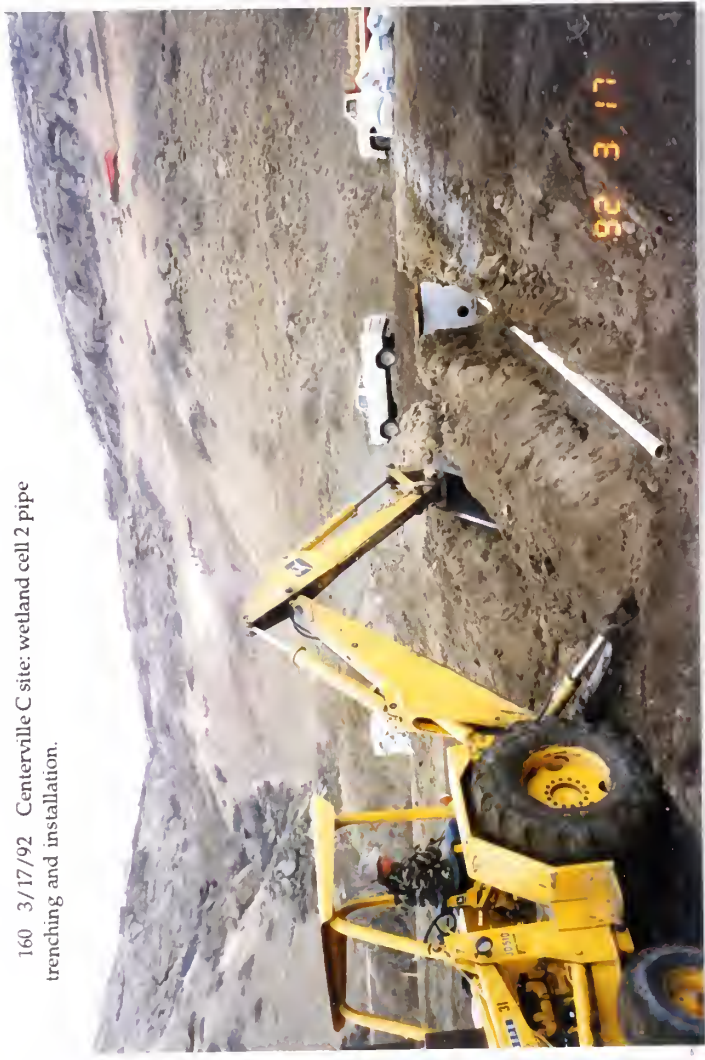
160 3/17/92 Centerville C site: wetland cell 2 pipe  
trenching and installation.

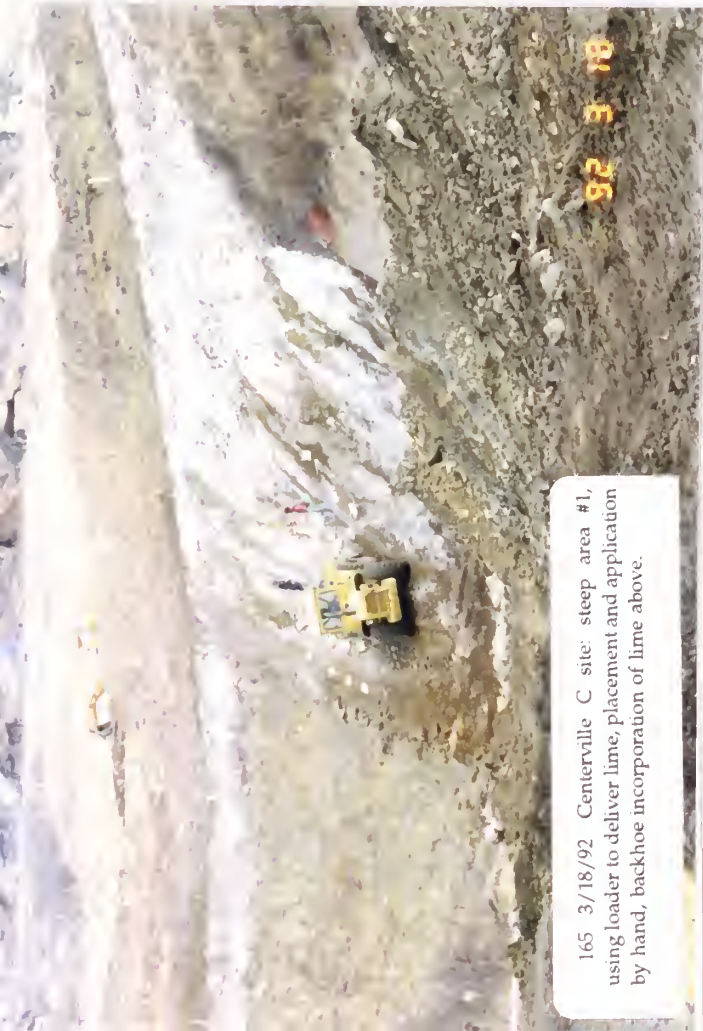
165 3/18/92 Centerville C site: steep area #1, using loader to deliver lime, placement and application by hand, backhoe incorporation of lime above.

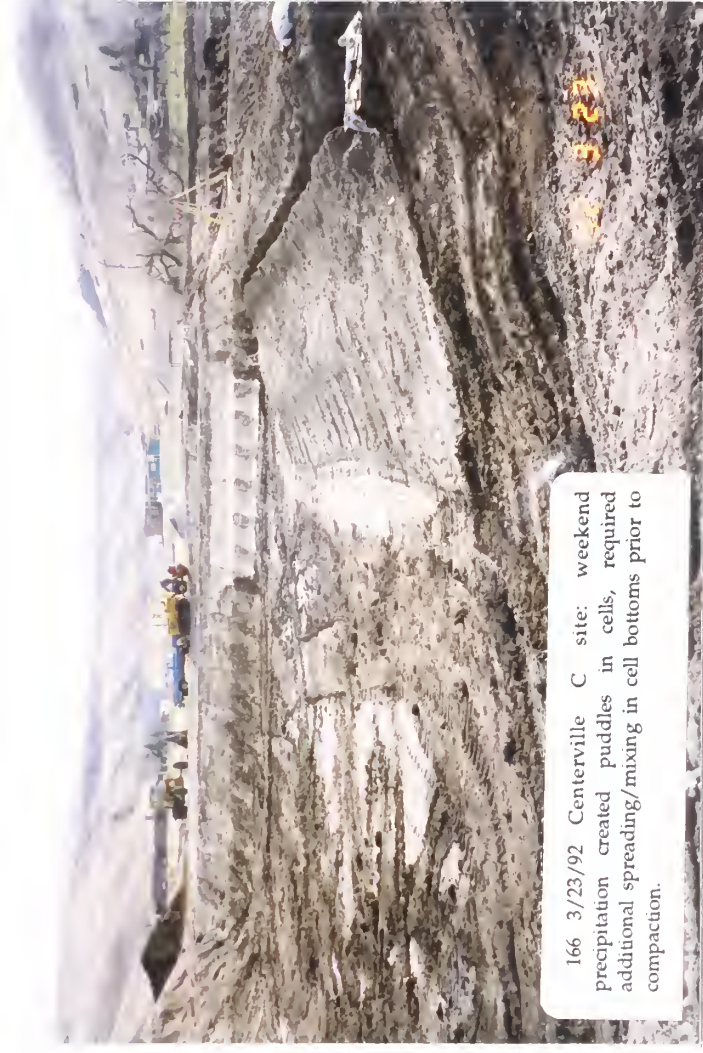
166 3/23/92 Centerville C site: weekend precipitation created puddles in cells, required additional spreading/mixing in cell bottoms prior to compaction.

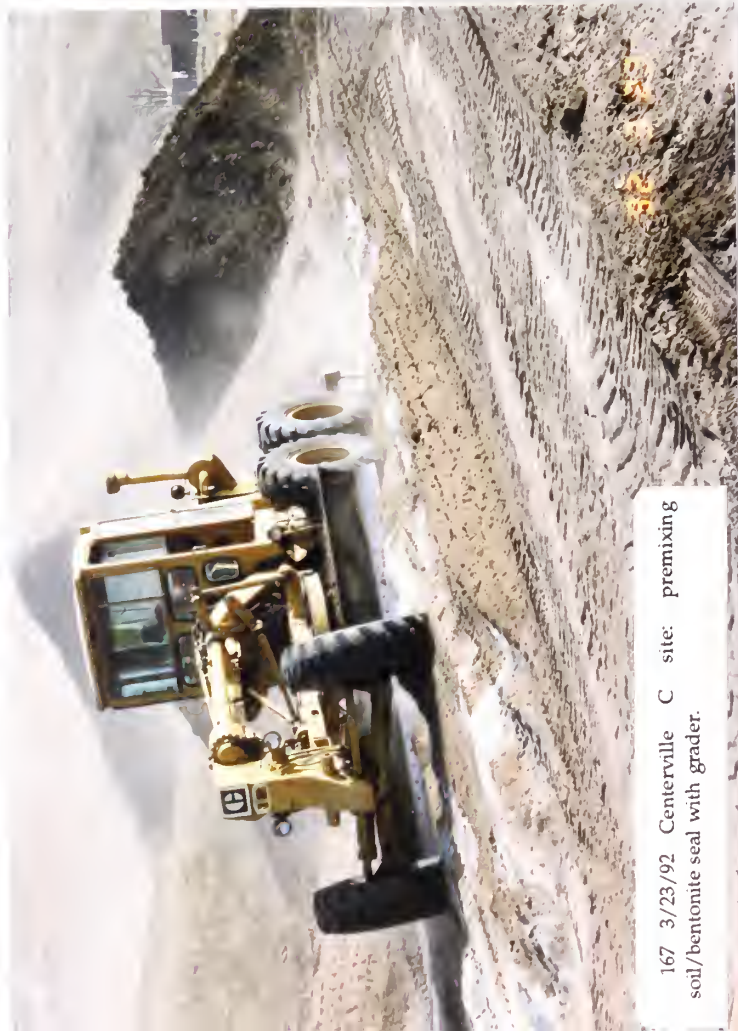
167 3/23/92 Centerville C site: premixing soil/bentonite seal with grader.

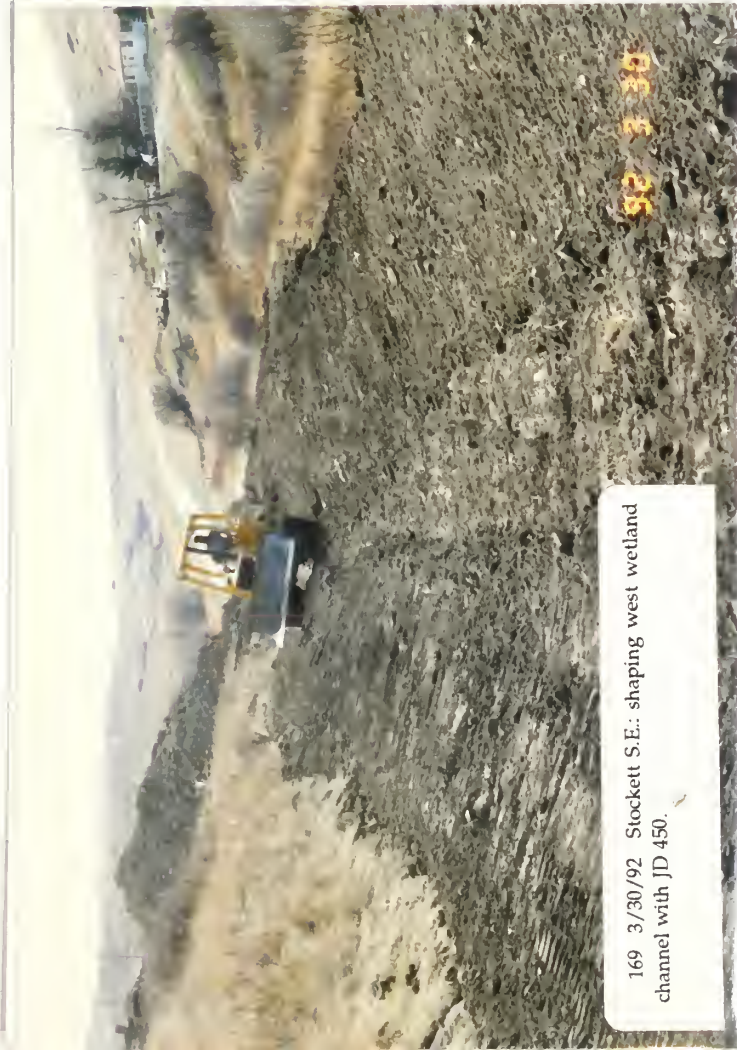
169 3/30/92 Stockett S.E.: shaping west wetland channel with JD 450.

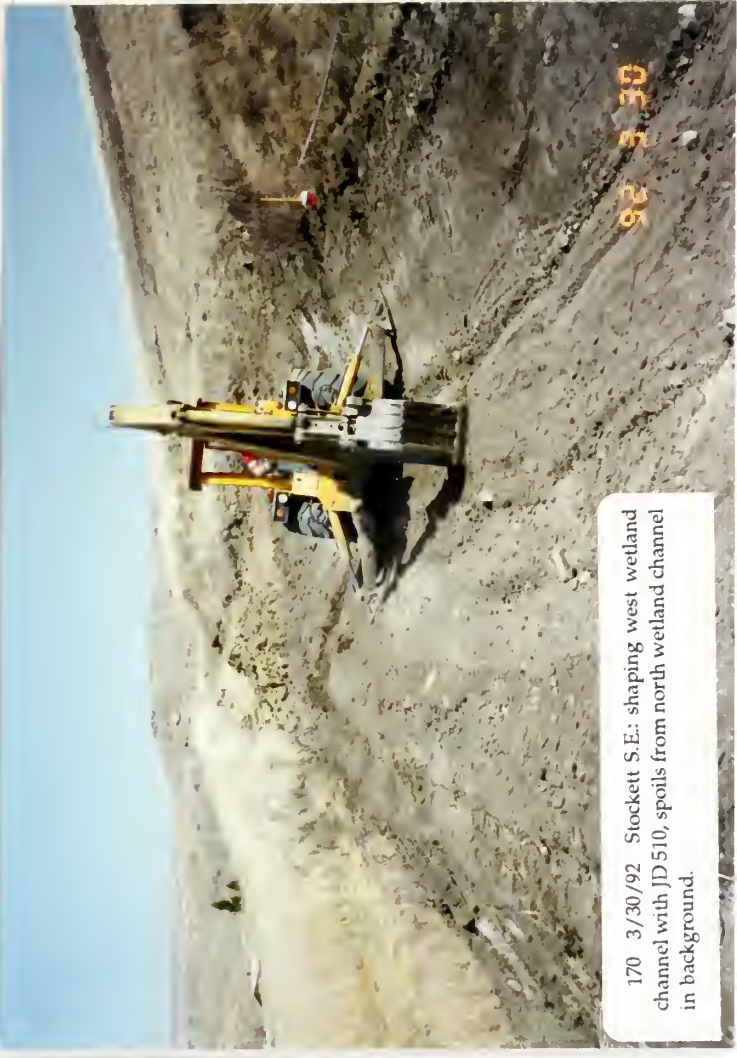
170 3/30/92 Stockett S.E.: shaping west wetland channel with JD 510, spoils from north wetland channel in background.

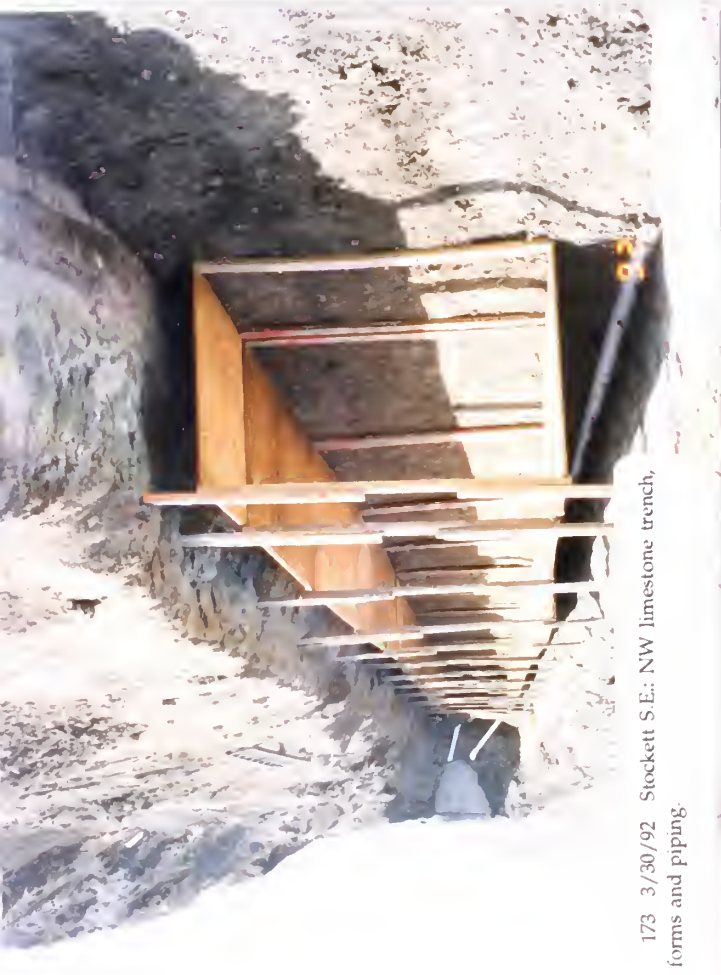
173 3/30/92 Stockett S.E.: NW limestone trench, forms and piping.

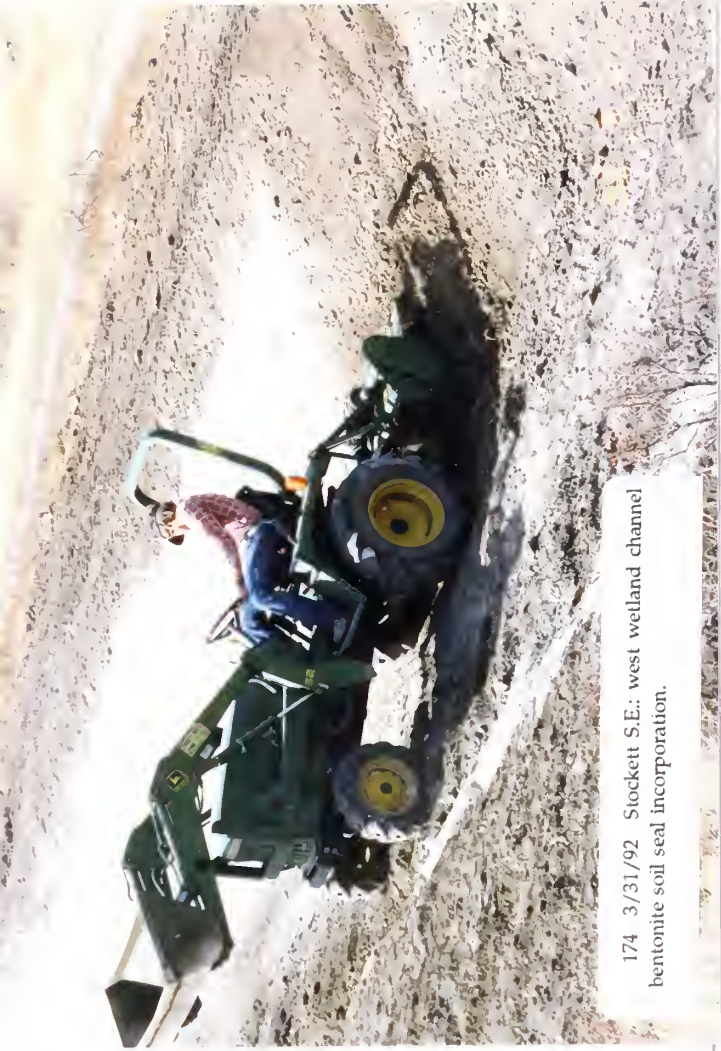
174 3/31/92 Stockett S.E.: west wetland channel bentonite soil seal incorporation.

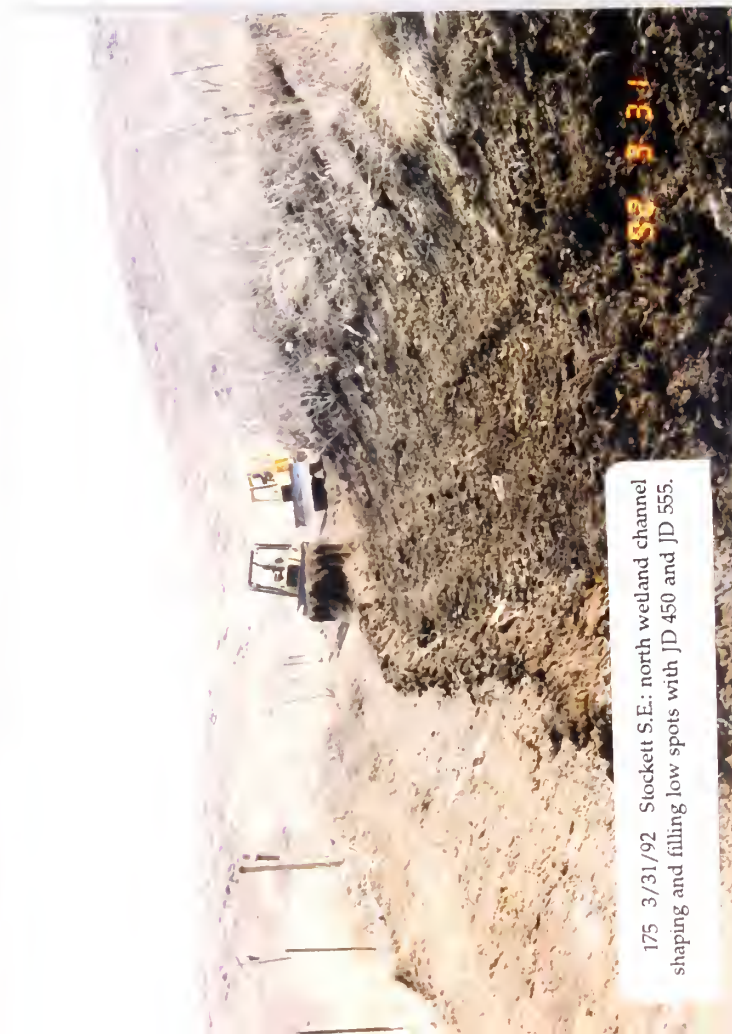
175 3/31/92 Stockett S.E.: north wetland channel shaping and filling low spots with JD 450 and JD 555.

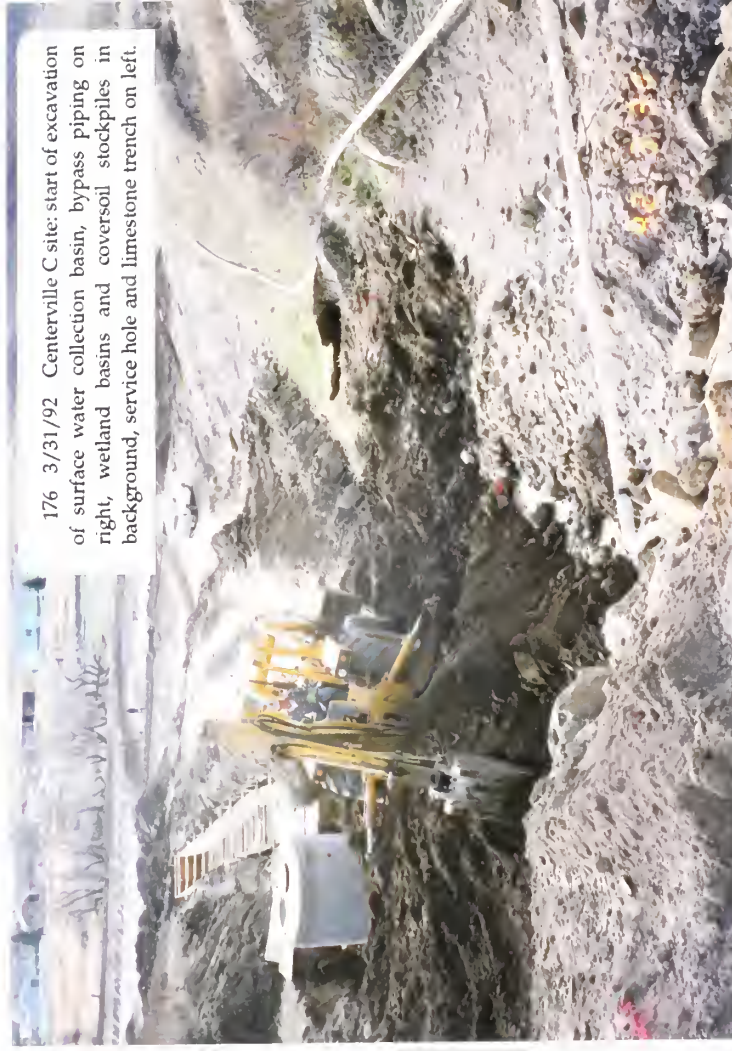
176 3/31/92 Centerville C site: start of excavation of surface water collection basin, bypass piping on right, wetland basins and coversoil stockpiles in background, service hole and limestone trench on left.

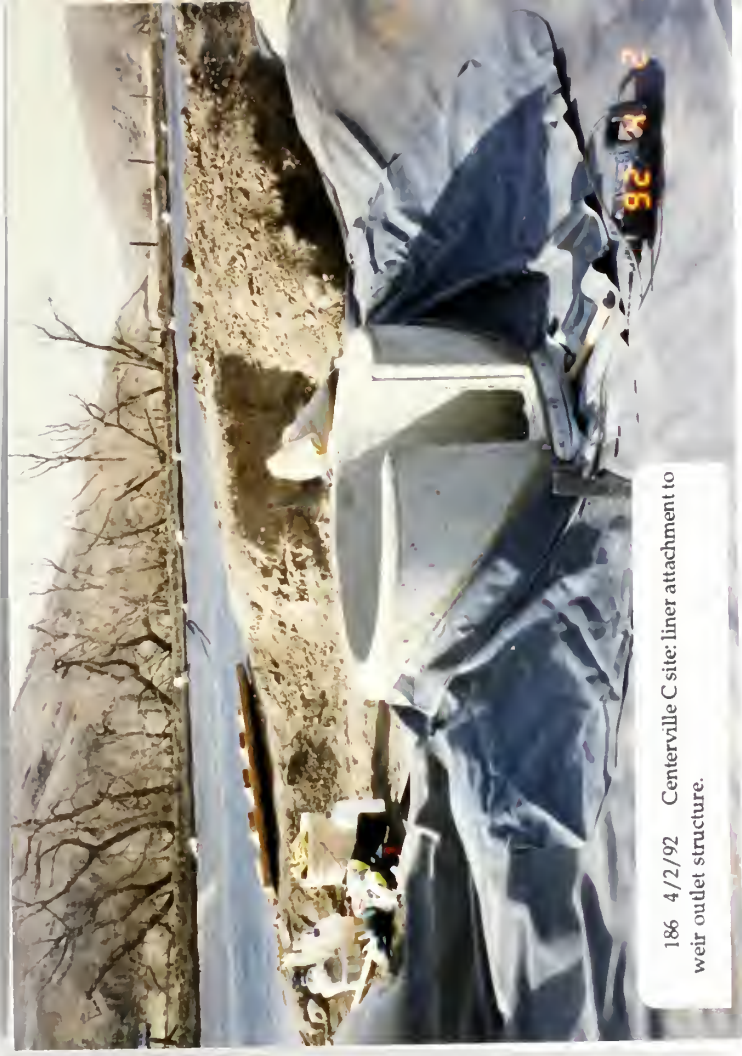
186 4/2/92 Centerville C site: liner attachment to weir outlet structure.

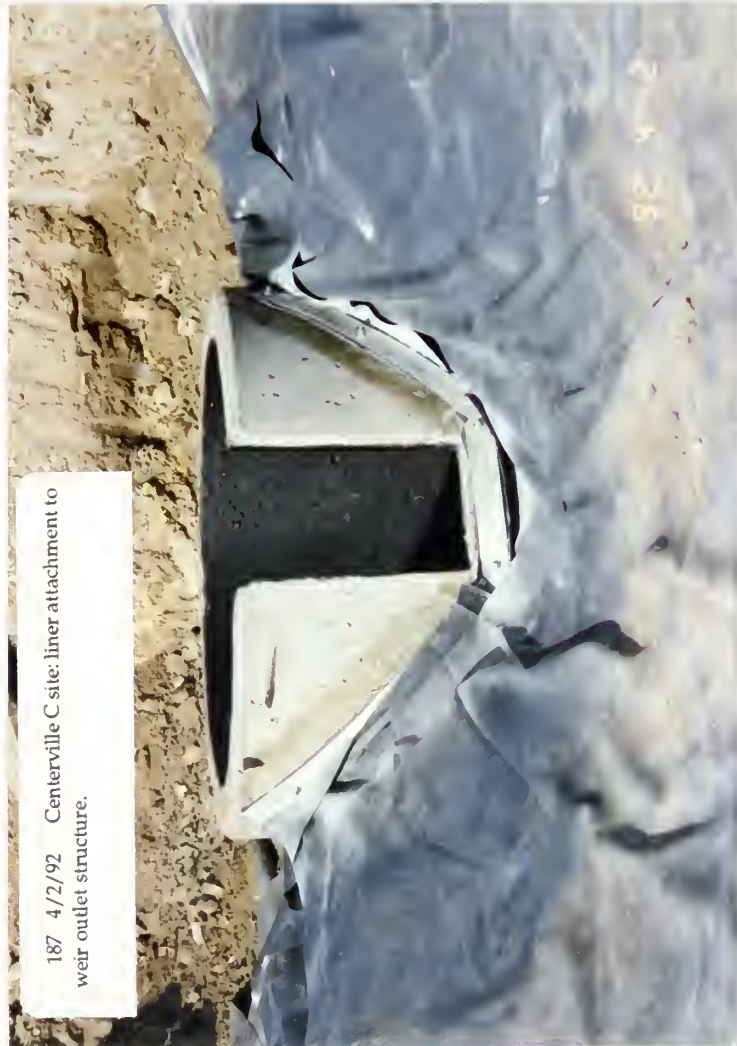
187 4/2/92 Centerville C site: liner attachment to weir outlet structure.

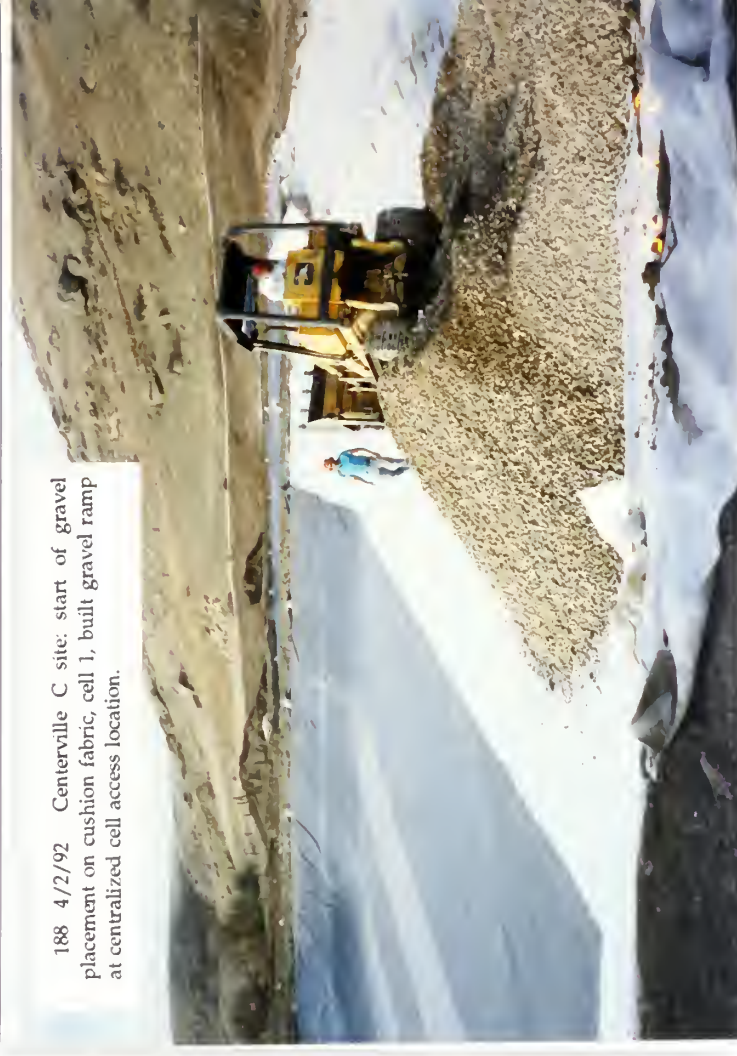
188 4/2/92 Centerville C site: start of gravel placement on cushion fabric, cell 1, built gravel ramp at centralized cell access location.

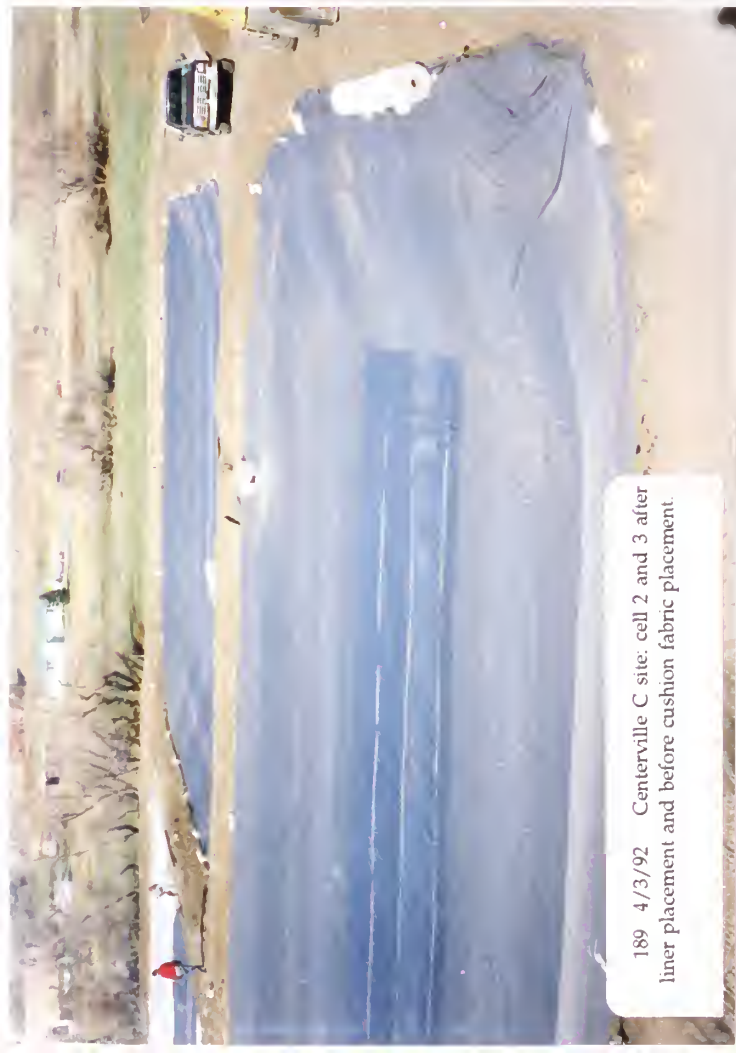
189 4/3/92 Centerville C site: cell 2 and 3 after liner placement and before cushion fabric placement.

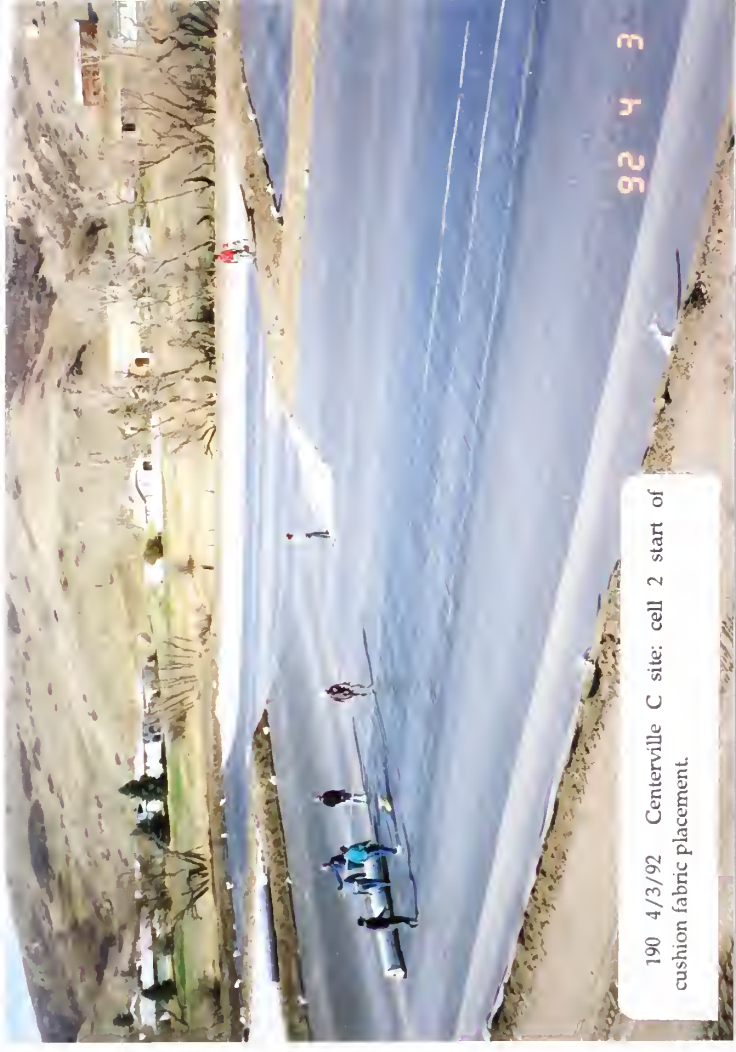
190 4/3/92 Centerville C site: cell 2 start of cushion fabric placement.

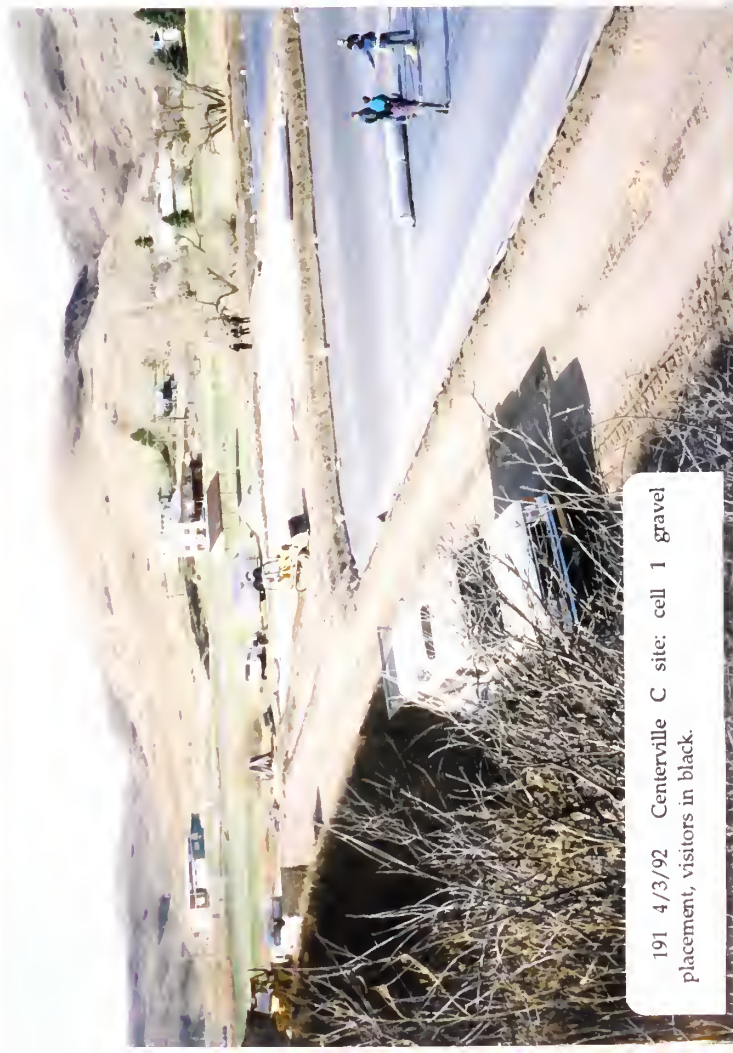
191 4/3/92 Centerville C site: cell 1 gravel placement, visitors in black.

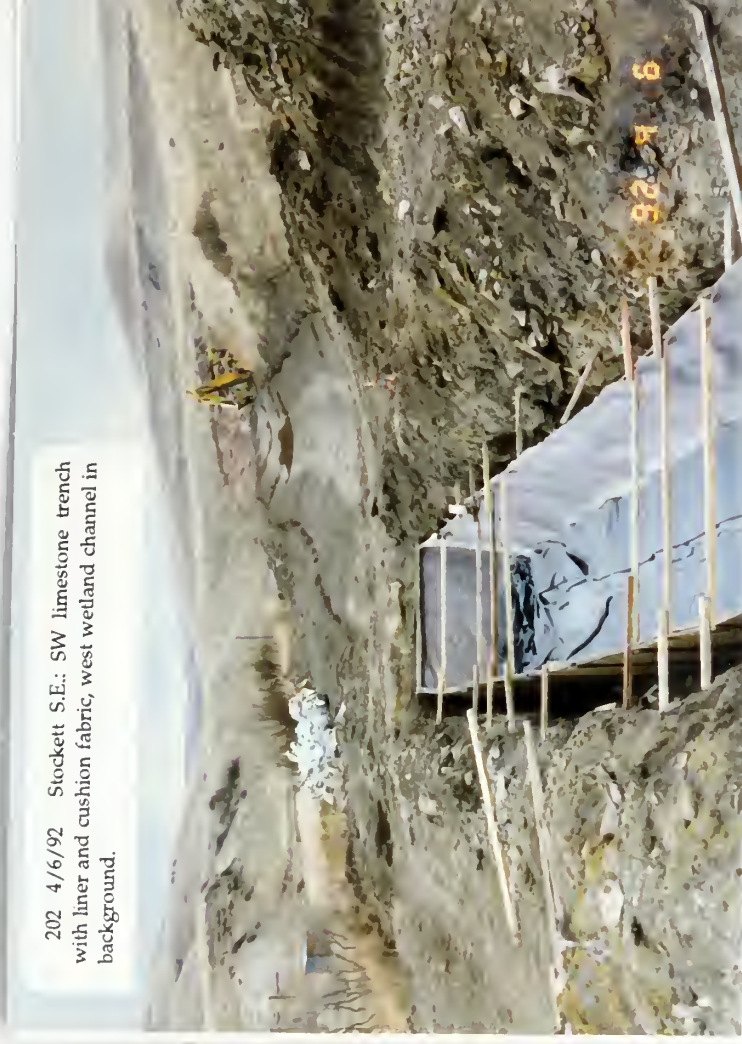
202 4/6/92 Stockett S.E.: SW limestone trench with liner and cushion fabric, west wetland channel in background.

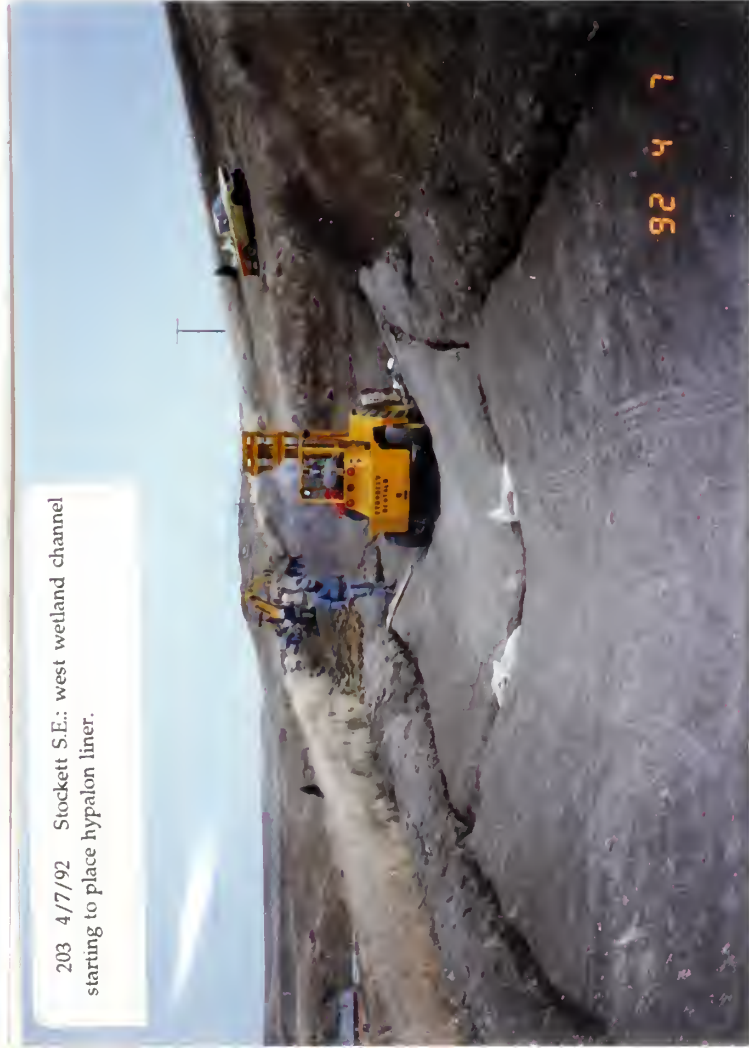
203 4/7/92 Stockett S.E.: west wetland channel starting to place hypalon liner.

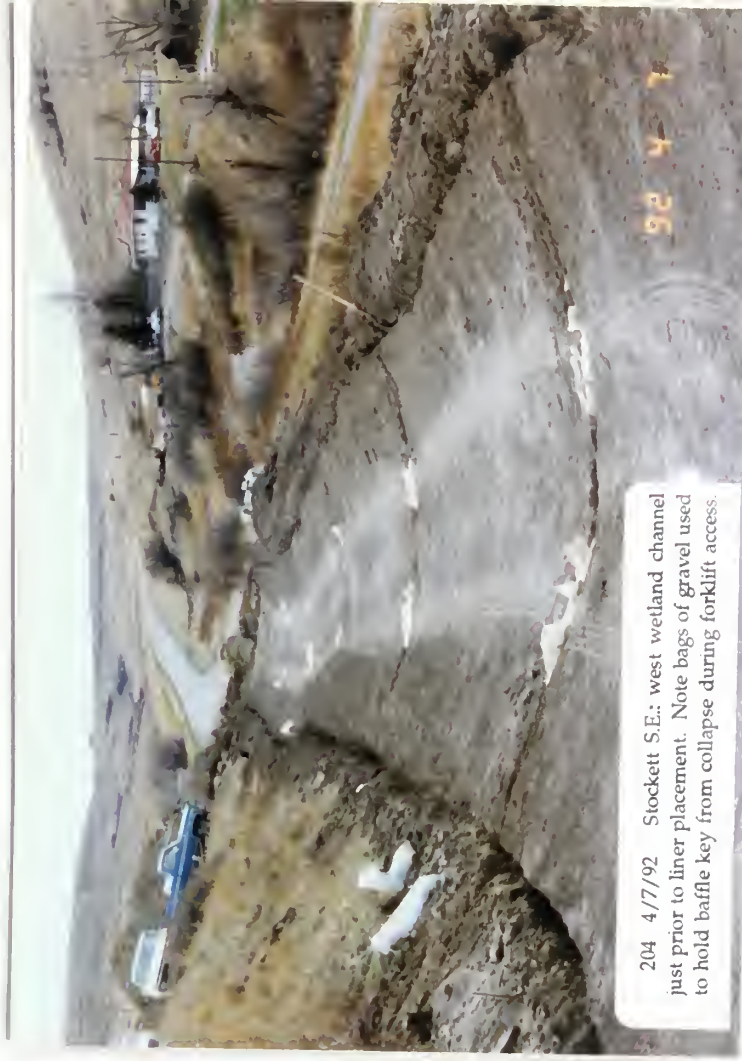
204 4/7/92 Stockett S.E.: west wetland channel just prior to liner placement. Note bags of gravel used to hold baffle key from collapse during forklift access.

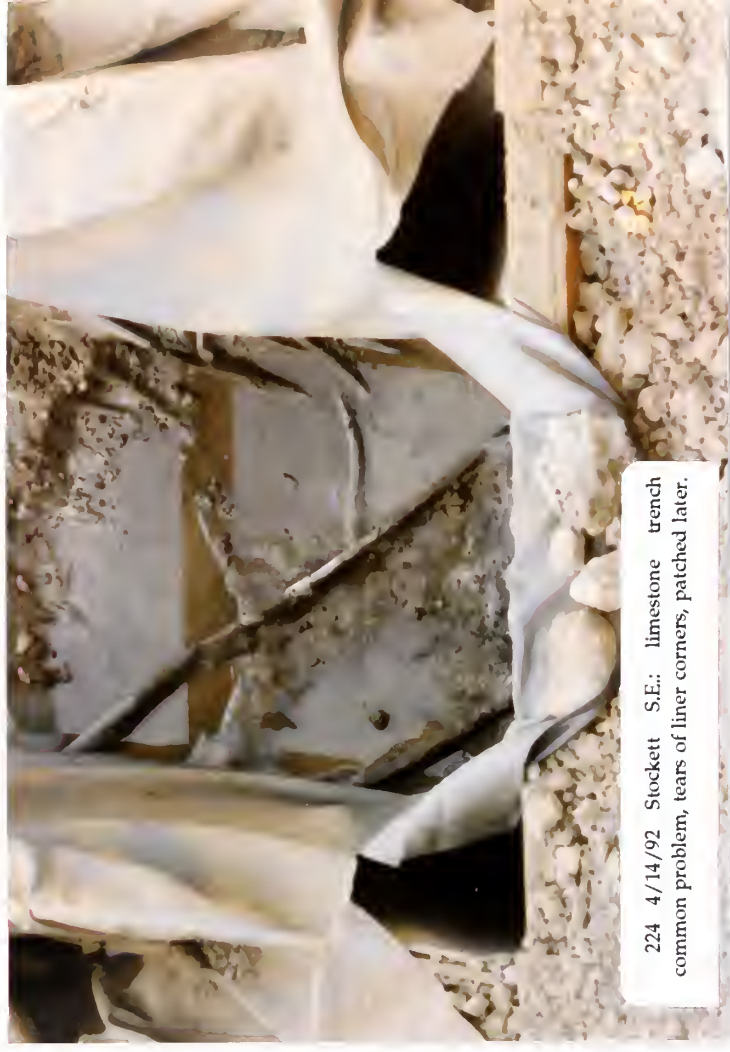
224 4/14/92 Stockett S.E.: limestone trench common problem, tears of liner corners, patched later.

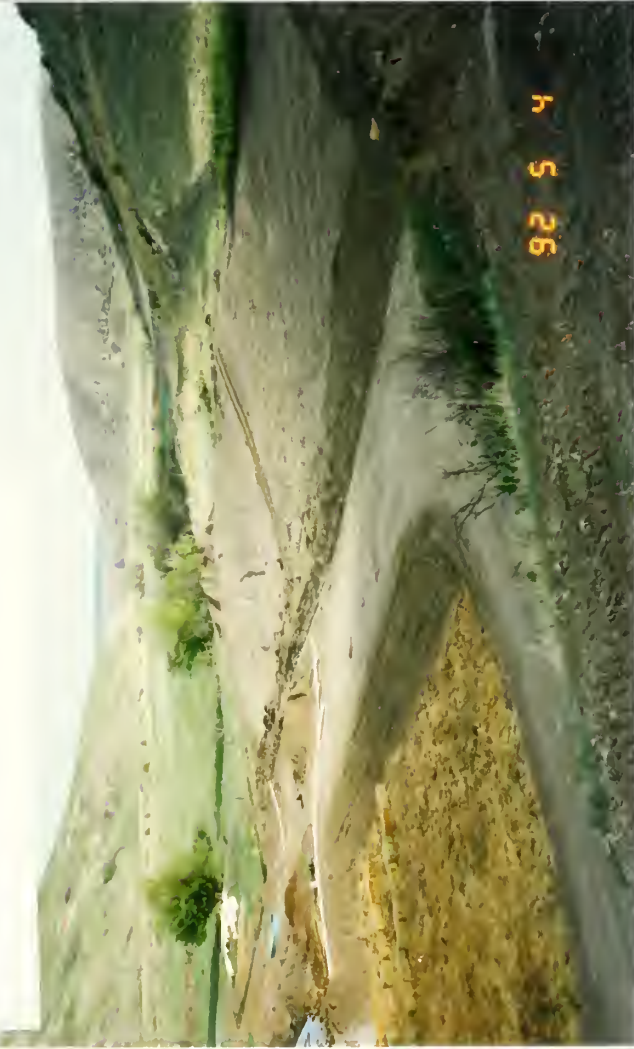
282 5/05/92 Centerville C site: fresh water from cell 3 released into Marko's channel making grading difficult.

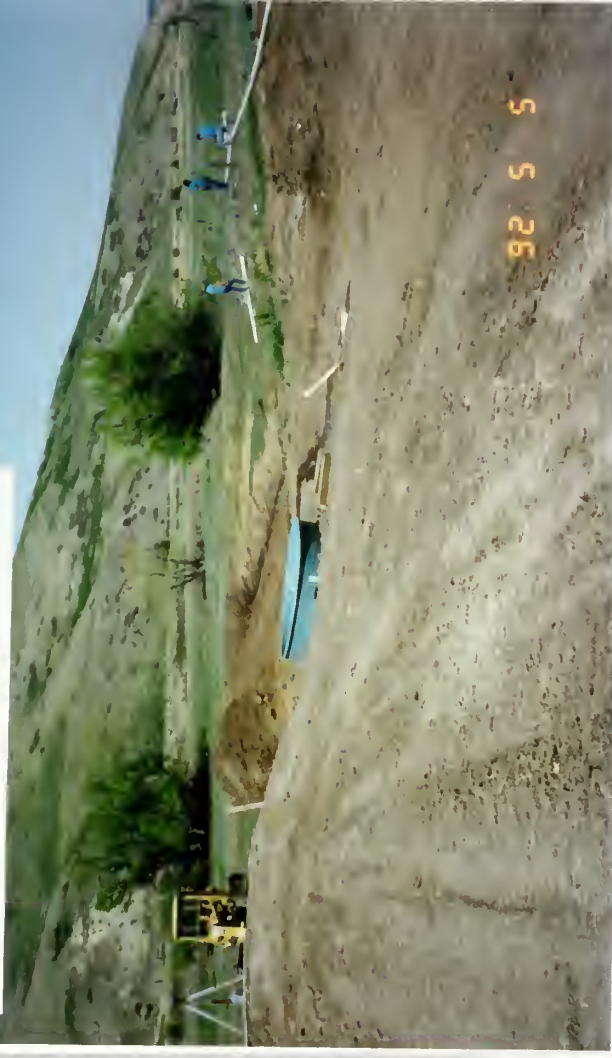
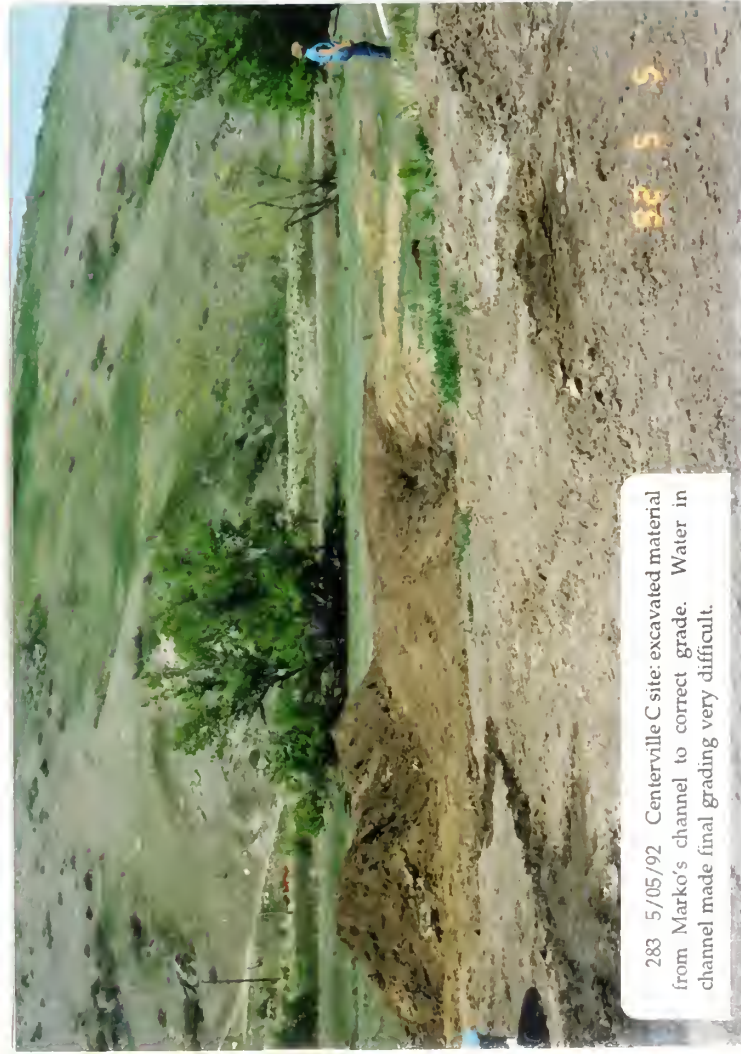
283 5/05/92 Centerville C site: excavated material from Marko's channel to correct grade. Water in channel made final grading very difficult.

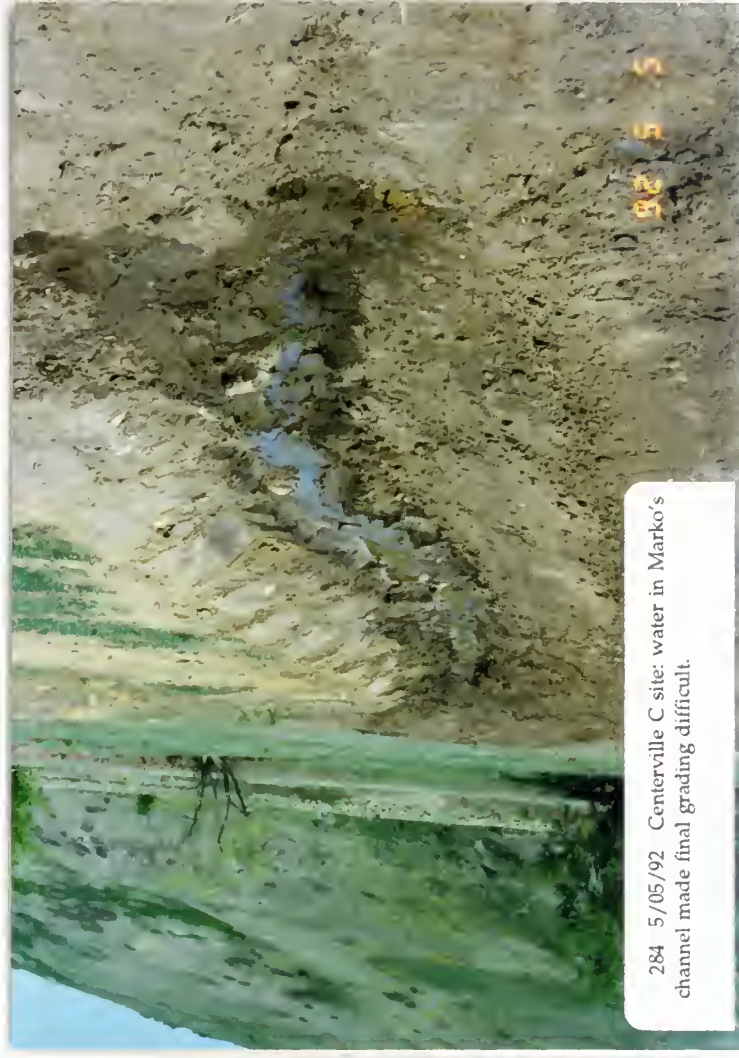
284 5/05/92 Centerville C site: water in Marko's channel made final grading difficult.

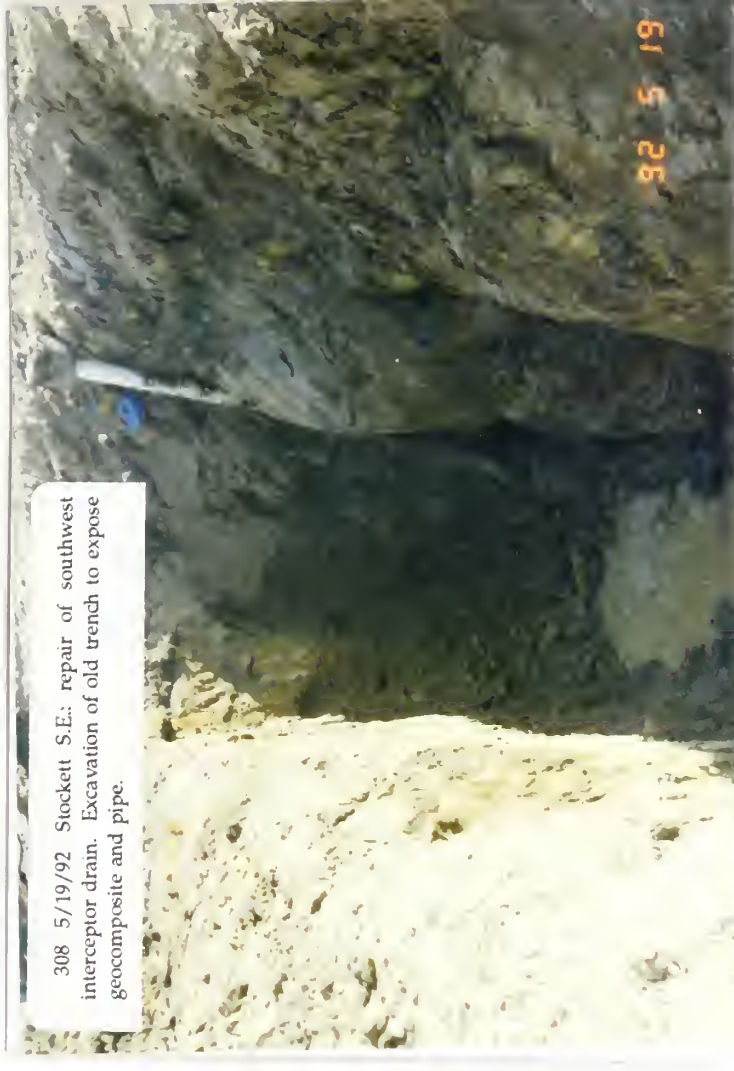
307 5/19/92 Stockett S.E.: repair of southwest interceptor drain. Excavation of old trench to expose geocomposite and pipe.

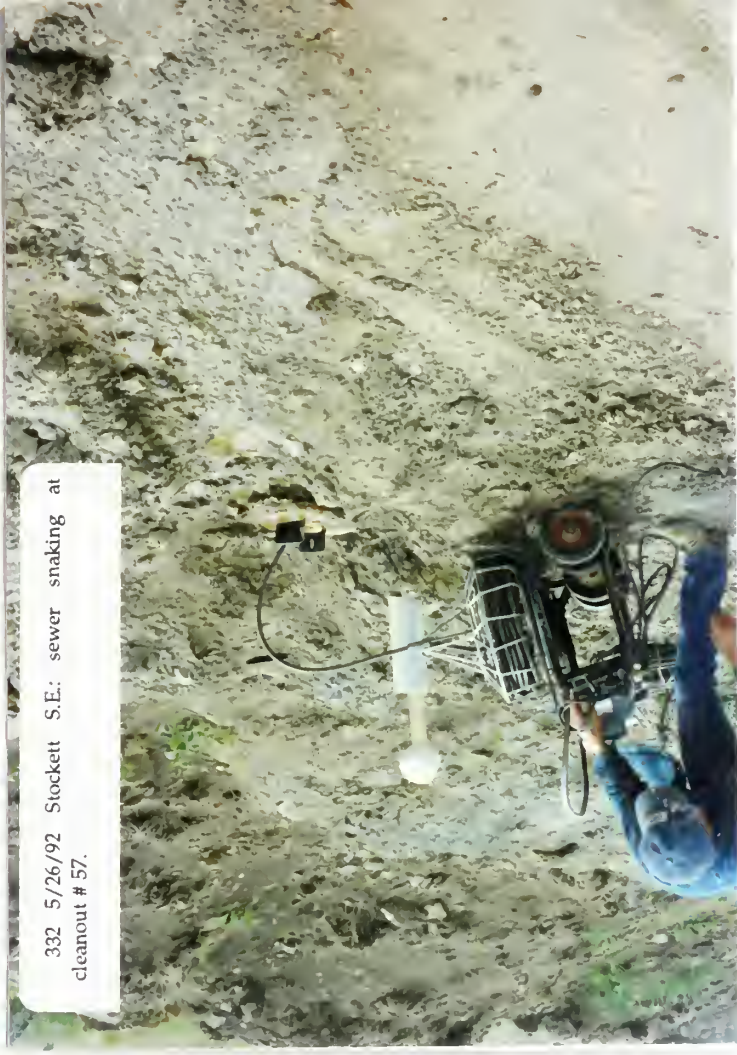
332 5/26/92 Stockett S.E.: sewer snaking at cleanout # 57.

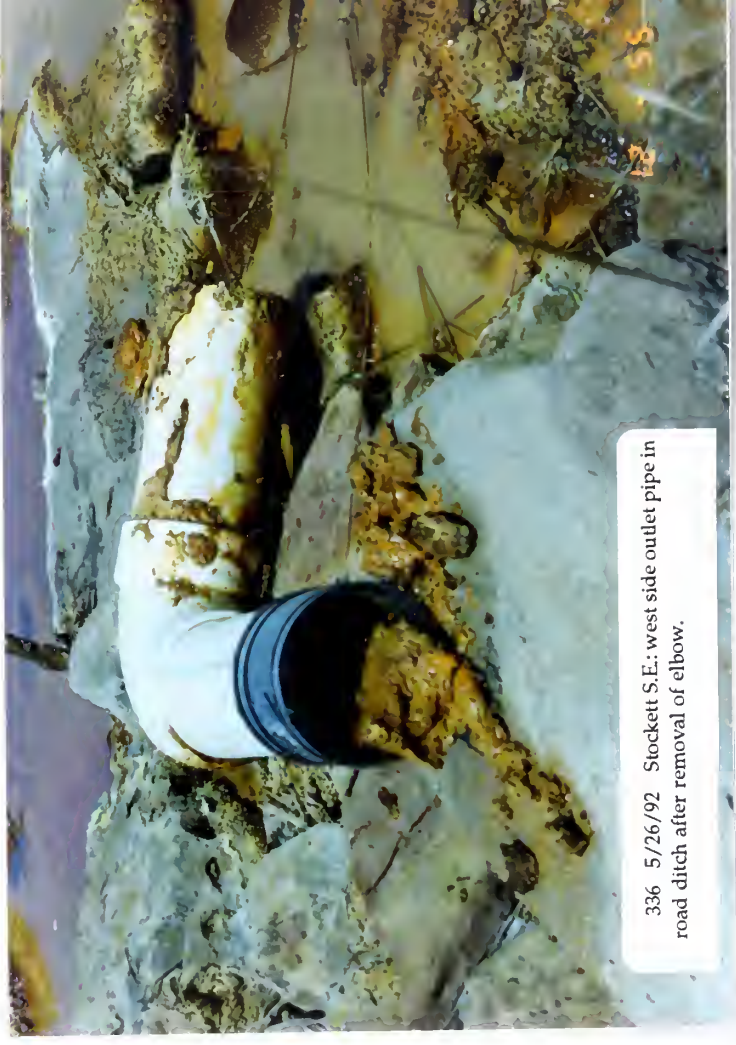
336 5/26/92 Stockett S.E.: west side outlet pipe in road ditch after removal of elbow.

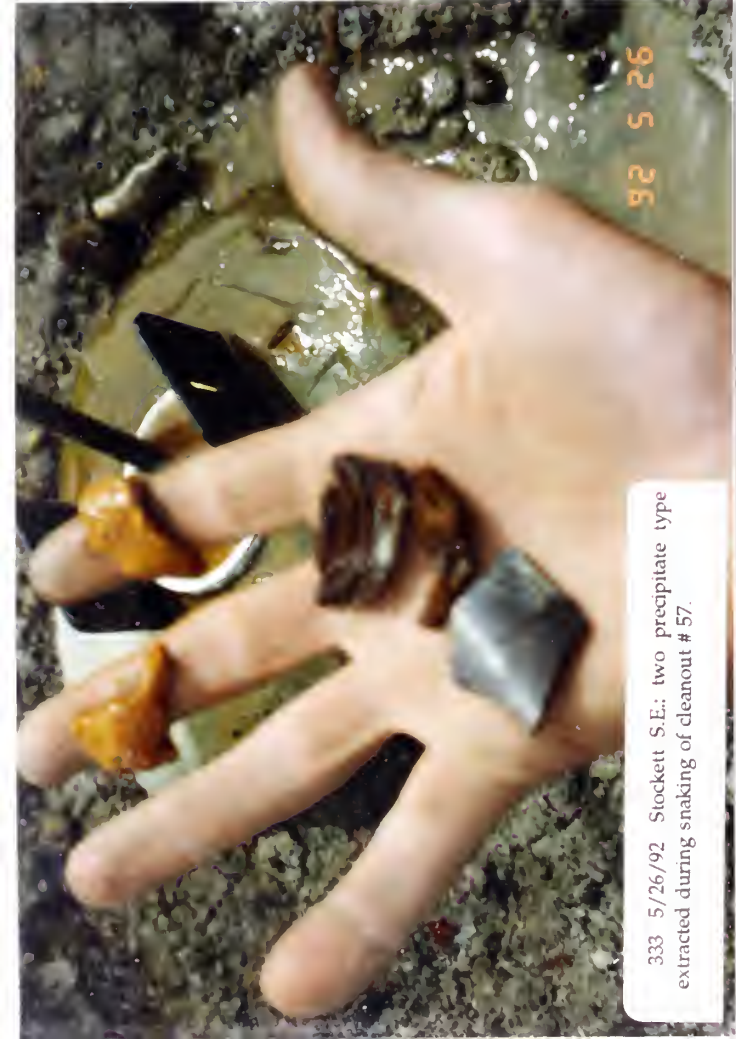
333 5/26/92 Stockett S.E.: two precipitate type extracted during snaking of cleanout # 57.

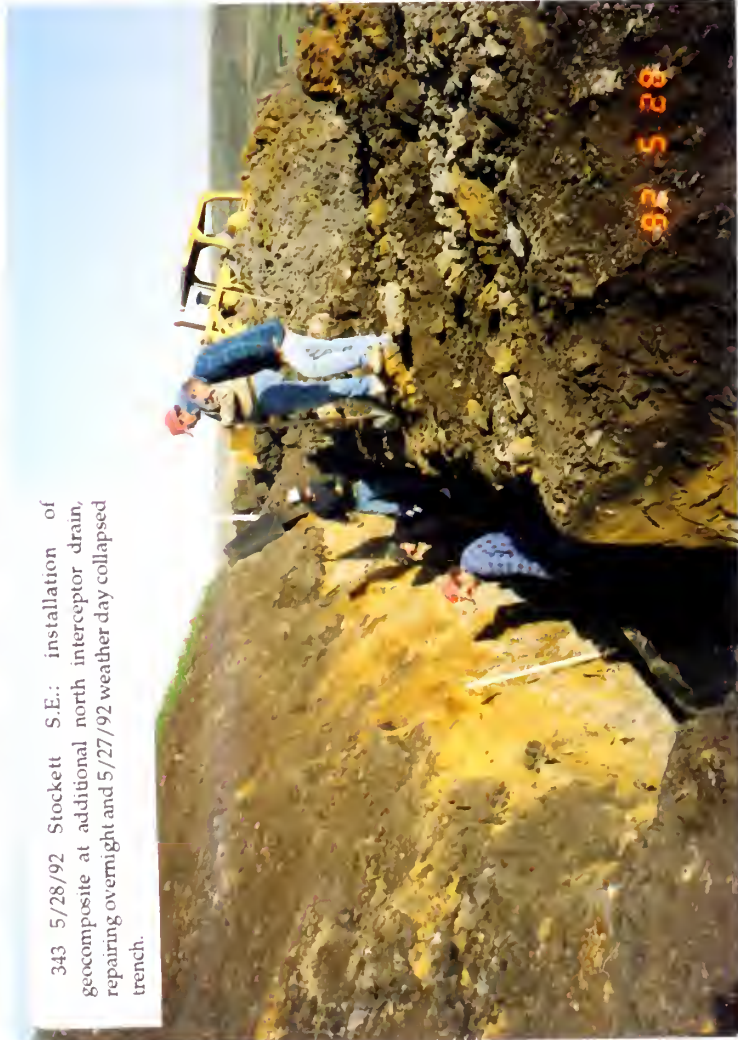
343 5/28/92 Stockett S.E.: installation of geocomposite at additional north interceptor drain, repairing overnight and 5/27/92 weather day collapsed trench.
